»» **Service Bulletin**

Number: B01-01 A

Subject: Push Rod Shroud Tube Interference with Cylinder Head Cooling Fins

Engine Application: Lycoming 360 and 320 Series Engines with Superior Cylinder Stud Assembly Part Numbers SL36000W-A1, SL36000N-A1, SL32000W-A1, SL32000N-A1 and SL32000NA-A1 Manufactured in October and November of 2000.

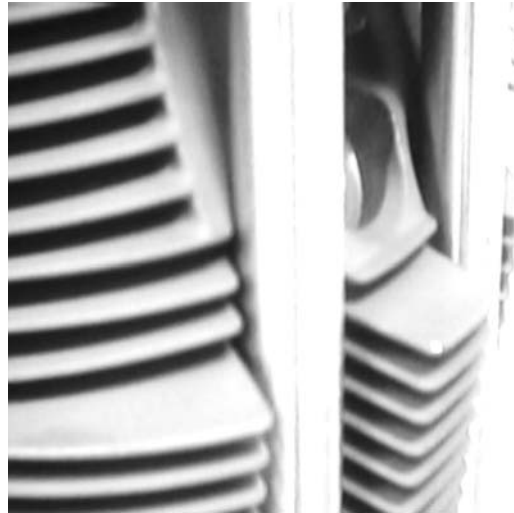
Figure 1. Exhaust Side

Some Superior cylinder assemblies for Lycoming 360 and 320 series parallel valve engines, manufactured in October and November of 2000, have excessive material on the cylinder head in the push rod shroud tube cutouts which results in interference between the shroud tubes and the cylinder head. In some cases the interference is obvious because it prevents the installation of the shroud tubes. In other cases, primarily on 320 series models, it may not be apparent. In all cases it must be corrected to allow for proper installation of the push rod shroud tubes and to eliminate any possibility that rubbing will damage the shroud tubes.

In the event that cylinder assemblies have already been installed, the clearance between the push rod shroud tubes and the cylinder head must be inspected to verify a minimum of .010 inches of clearance at all points. This is most easily accomplished using a .010 inch thick feeler gage, bent to fit around the back side of the push rod shroud tube. Several thinner feeler gages together equaling .010 inch thick may also be used. The .010 inch gage must pass freely up and down the Shroud tube between it and the cylinder head at all points. Any interference will occur at fin numbers 9 through 13, (counted from the bottom or barrel end of the head) toward the outside of the head on both tubes. The figures on page 3 of this Service Bulletin show the areas where interference may occur.

If interference is detected, the push rod and shroud tube must be removed and the area of interference must be ground down until proper clearance is achieved. This can be accomplished with a rotary file or sanding drum, since very little material must be removed. Use extreme care to cover all exposed parts, such as the valve lifters and the rocker box area to prevent contamination from the chips and abrasive. Do not remove more than .060 inch of material from the interfering surfaces.
