- Date:** September 28, 2010 **Mandatory Service Bulletin No. B08-01B**
- Subject:** Reprint of Precision Airmotive LLC Mandatory Service Bulletin PEX-1 REV 1 Dated 3/24/08
— *Hex Plug 383493 Coming Loose from Regulator Cover*
- Application:** Precision Airmotive LLC fuel injection servos having the serial numbers listed on the Precision Airmotive LLC website (www.precisionairmotive.com), which may have been:
1. Assembled on Superior Air Parts experimental XP engines,
 2. Kitted in Superior Air Parts experimental XP engine kits, or
 3. Purchased from Superior Air Parts independently.
- Compliance:** Upon receipt
- Warranty:** Contact Precision Airmotive LLC (360-651-8282) for warranty support related to this issue

Bulletin No.: PEX-1
Revision No: 1
Date: 3/24/08

SUBJECT: HEX PLUG 383493 COMING LOOSE FROM REGULATOR COVER

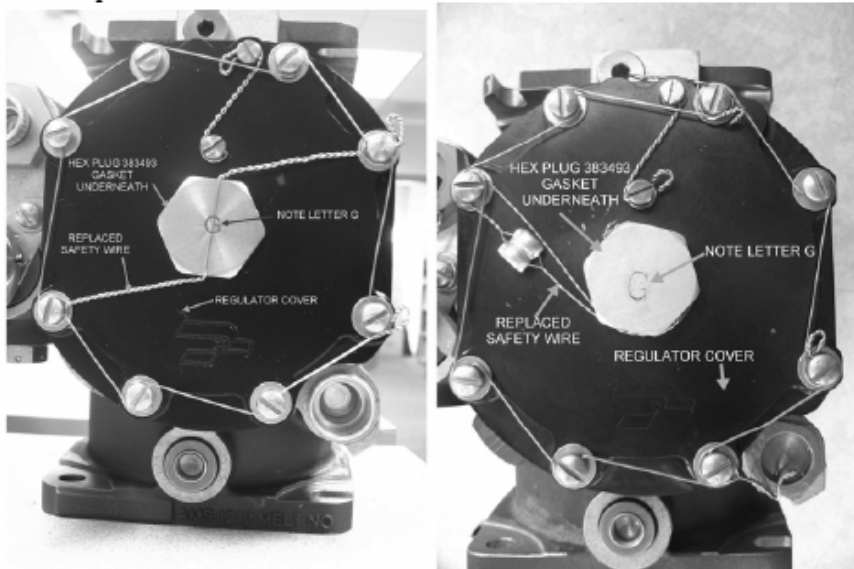
Note: The safety wire through the hex plug shown in the left hand photo is .025" wire wrapped around regulator screws under existing wire. It does not go through the holes in the screws. The safety wire through the hex plug shown in the right hand photo is .015" wire which passes through the regulator screw hole. This is the normal safety wire method used at the factory.

IMPORTANT: The letter "G" shown in the photos is to be stamped **ONLY** if the new gasket, part number 2577258 has been installed.

6. With an acceptable hex plug, an acceptable regulator cover, and an acceptable gasket, install the gasket over the hex plug and install plug into the regulator cover. Torque the hex plug to 90-100 in-lbs.
7. The hex plug must be safety wired with .015 or .025 inch diameter wire to the regulator cover as shown in the photos below. The wire shall pass thru the plug such that it pulls the plug in the tightened direction and does not rest on the corners of the hex on the plug (it is acceptable to wrap under the corners of the hex plug). These photos are just two examples of acceptable safety methods. Other safety methods such as those described in FAA AC 43-13 are also acceptable.
