>>> Service Letter

Number: L01-02 B
Replaces L01-02 A

Subject: Overhaul and repair procedures for Superior Accessory Housing Assemblies

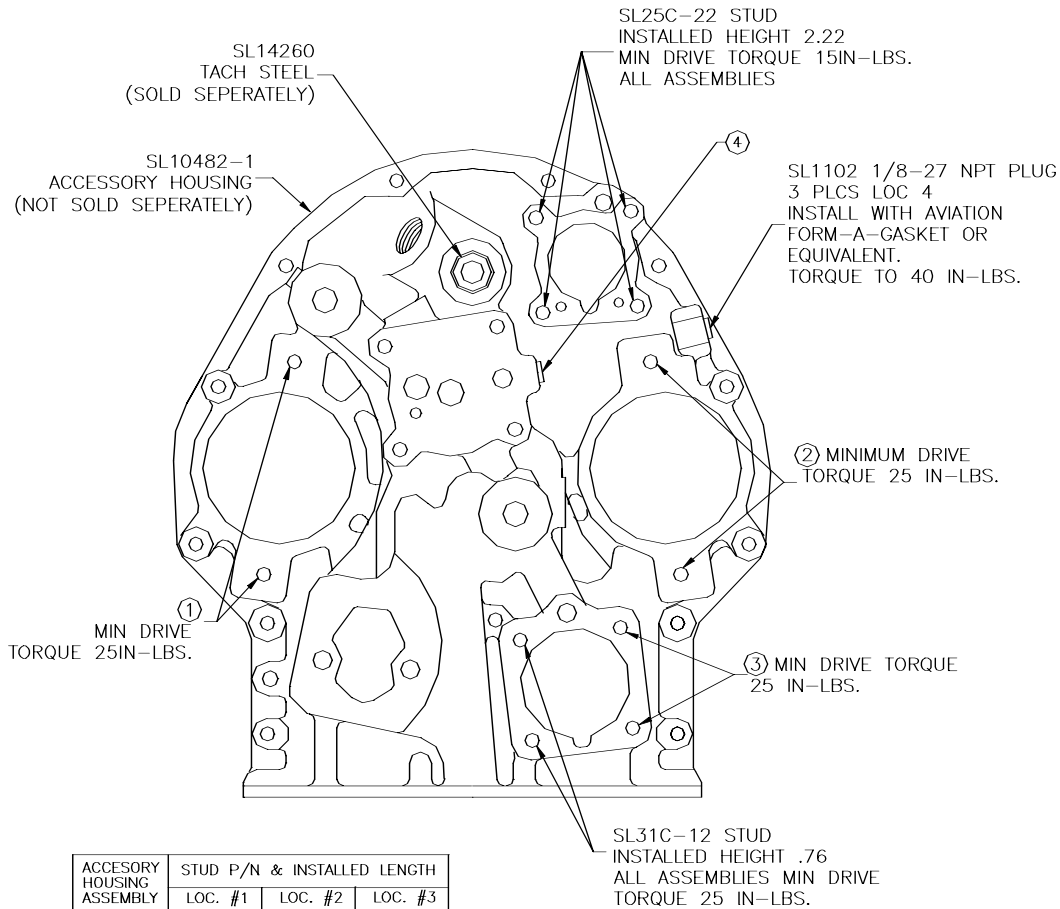
Figure 1
Accessory Housing Assembly

ACCESSORY HOUSING ASSEMBLY	STUD P/N & INSTALLED LENGTH		
	LOC. #1	LOC. #2	LOC. #3
SL10482 SL76110	SL31C-19 1.78"	SL31C-12 .94"	SL31C-12 .76"
SL76111	SL31C-12 .94"	SL31C-12 .94"	SL31C-13 .88"
SL77997	SL31C-19 1.78"	SL31C-19 1.78"	SL31C-12 .76"

Remove all plugs and clean the oil passages. The aluminum housing must be subjected to fluorescent particle inspection per AMS 2645 and accepted per MIL-STD-1907, grade B (or other FAA approved repair station procedure). Visually inspect wear surfaces, oil pump shaft bearing bores, tachometer drive bore and fuel pump push rod bore for wear or damage. The oil pump shaft bearing, tachometer drive and fuel pump push rod bores must be inspected for acceptable size and clearance to the mating parts. The tachometer oil seal must be removed and replaced. Studs must be inspected for damage and replaced as necessary. Figures 1 and 2 provide replacement part numbers, installation instructions and critical dimensions.
