**>>> Service Letter**

**Number: L01-14 A**

**Subject:** Overhaul and repair of Superior Idler Gear

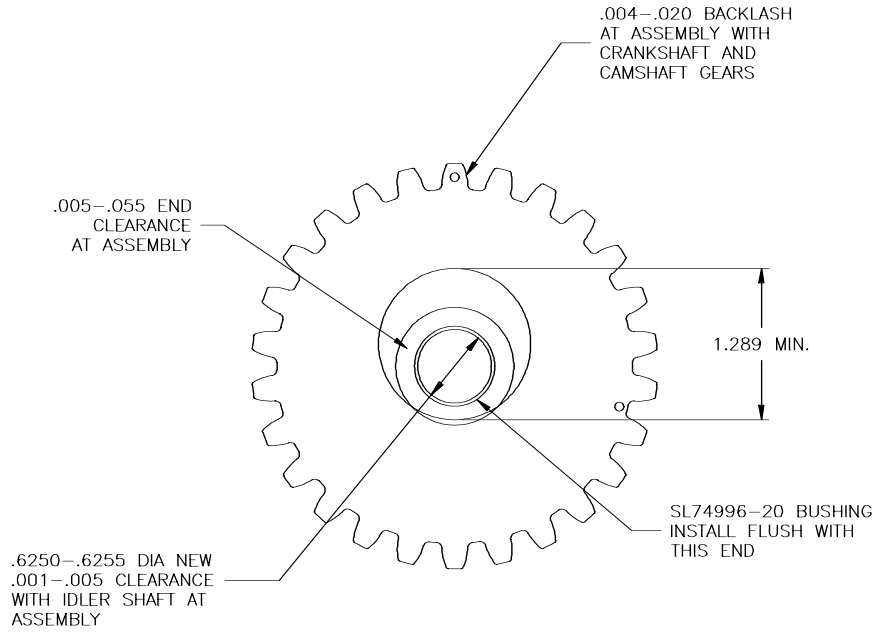
FIGURE 1  
IDLER GEAR  
(SL75072 SHOWN, SL74996  
IDENTICAL EXCEPT IT DOES  
NOT HAVE A FUEL PUMP  
CAM LOBE)

The gear assemblies should be visually inspected for abnormal wear or damage, paying close attention to the gear teeth and on the SL75072, the fuel pump eccentric lobe. The gear assemblies are to be magnetic particle inspected per ASTM E1444 and accepted per MIL-STD-1907, grade B (or other FAA approved repair station procedures). The allowable bushing inside diameter, clearances, pump lobe dimension, and gear backlash are shown in Figure 1.

If the bushing inside diameter is worn beyond allowable clearance limits, it may be replaced. Press out the old bushing and inspect the gear inside diameter to insure it is within the limits shown in Figure 1. Lubricated the new bushing and press it in using a suitable installation tool and arbor press. Do not drive the bushing in with a hammer. The bushing must then be burnished to the .6250/.6255 dimension. This procedure is not recommended unless the proper tools are available.
