>>> Service Letter

Number: L01-23A

Subject: Overhaul and repair for Superior Valve Rocker.

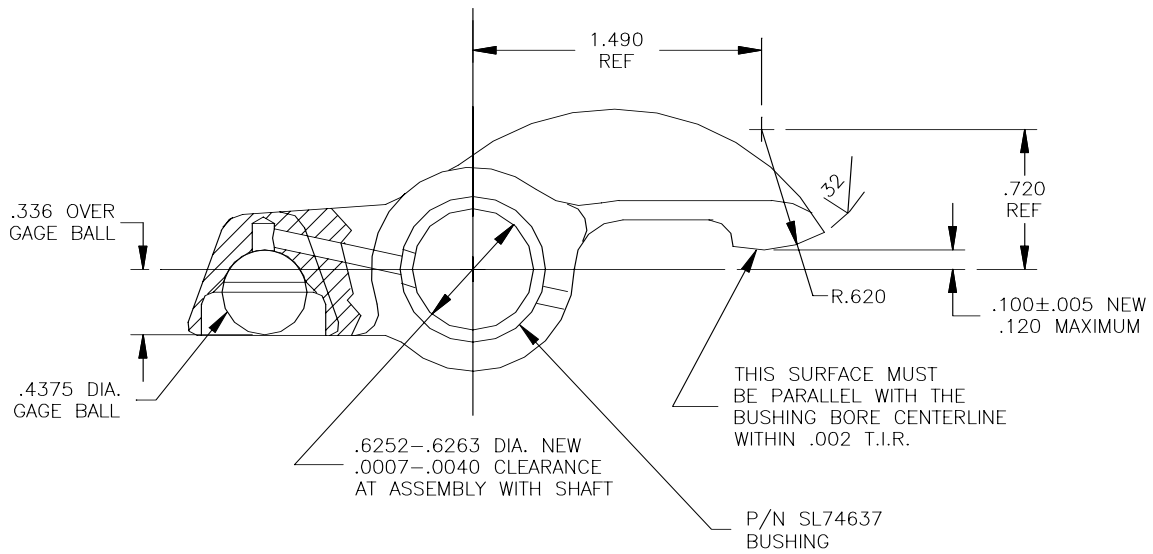
FIGURE 1
ROCKER ARM ASSEMBLY

The rocker arm should be visually inspected for abnormal wear or damage, paying close attention to the toe and bushing bore. The rocker arm is to be magnetic particle inspected per ASTM E1444 and accepted per MIL-STD-1907, grade A (or other FAA approved repair station procedures). The allowable bushing bore size and part number, along with other overhaul instructions, are given in Figure 1.

If the bushing inside diameter is worn beyond allowable clearance limits, it may be replaced. Press out the old bushing and inspect the rocker arm inside diameter to insure it is not scored or out of round. The lubricated new P/N SL74637 bushing is then pressed in using a suitable installation tool and arbor press. Make sure it is flush or below the rocker arm surface on both ends. Do not drive the bushing in with a hammer. The bushing must then be burnished to the .6252-.6263 diameter. This procedure is not recommended unless the proper tools are available.
