Service Letter

Number: L02-01 A

Subject: Fuel Injector Crack Inspection of older SA52000-A1 cylinder stud assemblies.

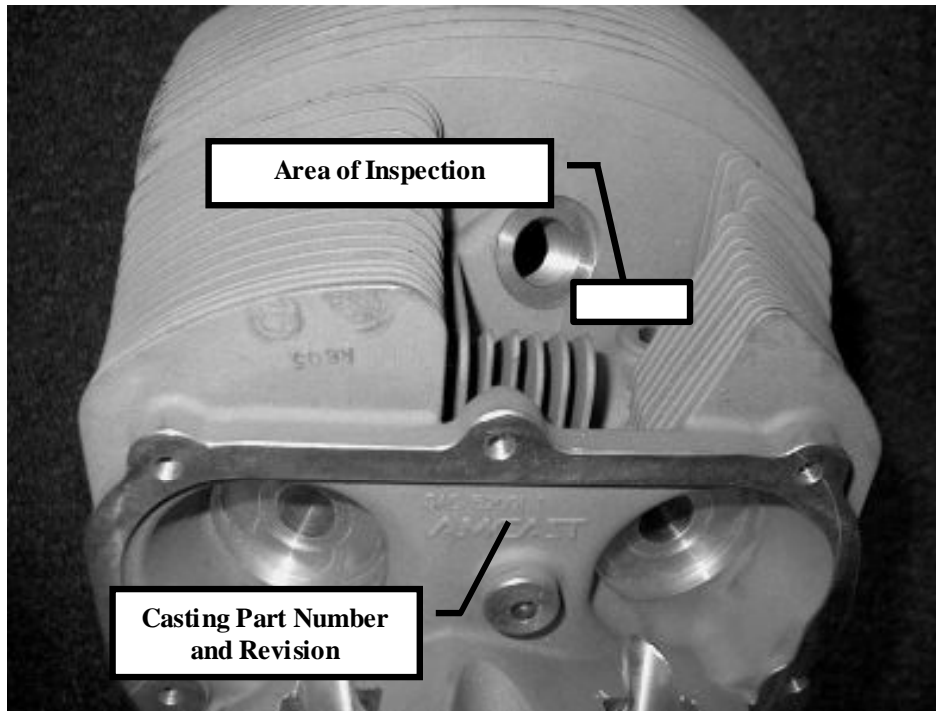
This Service Letter covers inspection of Superior Air Parts, Inc. SA52000 series Millennium® cylinders for cracking between the radius, below the fuel injector boss and the upper spark plug boss (see Figure 1). A small number of early models of Superior's 520 cylinder heads have been reported to crack in this area. This type of cracking has previously occurred on TCM 520 engines and mechanics have historically inspected this area for indications regardless of cylinder manufacturer. The purpose of this Service Letter is to recommend that early models of Superior's 520 cylinders be included in this inspection. Only Superior 520 cylinders manufactured before May 2000 and manufactured with castings identified as SAC52001I or SAC52001I B are susceptible to this cracking. The casting identification can be found in the rocker box area above the valves, as seen in Figure 1. Later castings manufactured by Superior Air Parts have had no reports of cracking.

Inspect applicable cylinders in the area shown in Figure 1 at every 100 Hour Inspection. The area is easily visible and should require no additional labor during the usual visual inspection. If any indication of cracking is found during inspection remove and replace the affected cylinder.
