»» **Service Letter**

Number: L95-03A

Subject: Primer Nozzle/Fuel Injection Interference

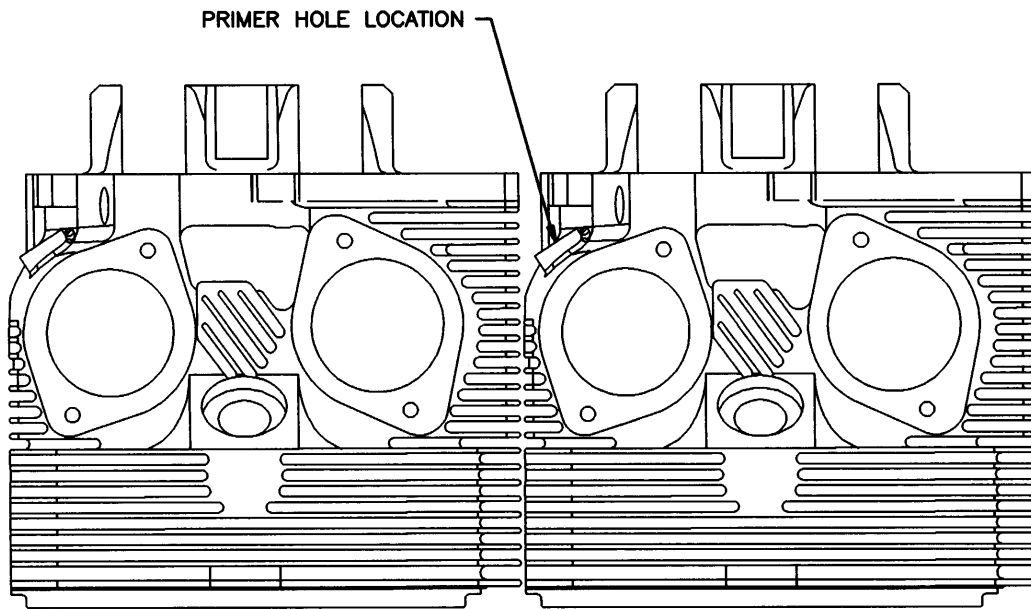
FIG 1

Superior Air Parts, Inc. has become aware that certain primer and fuel injection nozzles cannot be installed on these cylinders or interfere with the adjacent cylinder or with the cylinder head casting itself when installed in the location shown in Figure 1.

Modify the Millennium® Cylinder only when necessary for installation clearance. Carefully grind the interfering portion of the cylinder head to provide a minimum of .045 inch and a maximum of .090 inch clearance.
