»» **Service Letter**

Number: L99-19 B

Date: 07/15/2004

Subject: Overhaul and repair of Superior connecting rods

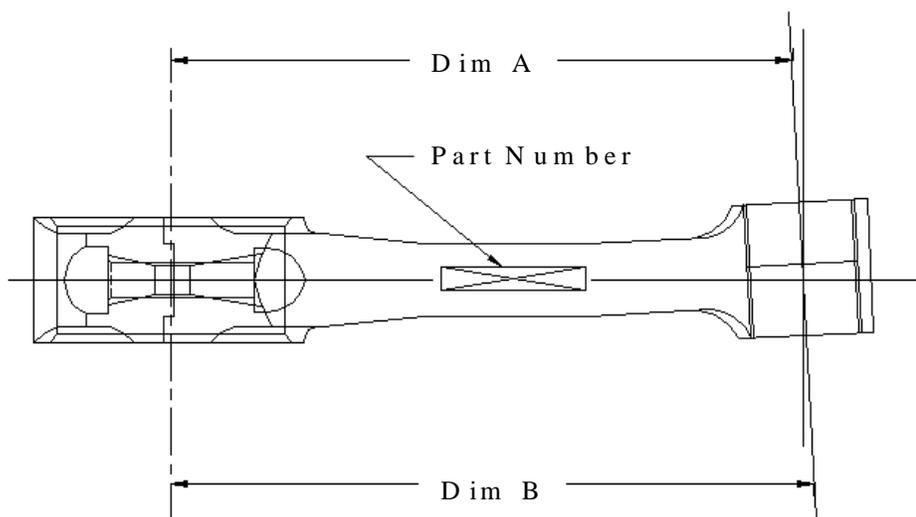
Figure 2

If the connecting rod gage described in the OEM Overhaul Manual is available, the following procedure will be used. With the rod installed on the gage, the difference between Dimensions "A" and "B", in Figure 2, must not vary more than .001 inch per inch of separation between the points at which "A" and "B" are measured. In other words, if "A" is measured 3 inches on one side of the rod and "B" is measured 3 inches on the other side, a spread of 6 inches, then "A" must equal "B" within .001 X 6 or .006 inch or less. If the difference exceeds .001 inch per inch, the rod must be rejected.
