»» **Service Bulletin**

Number: B08-04 A

- Date:** 07/21/08 **Mandatory Service Bulletin No. B08-04**
- Subject:** Reprint of MANDATORY Unison Slick Service Bulletin No. SB3-08 – Premature carbon brush wear.

SUBJECT: Mandatory inspections on all Slick 4300/6300 and LASAR™ 4700/6700 magnetos

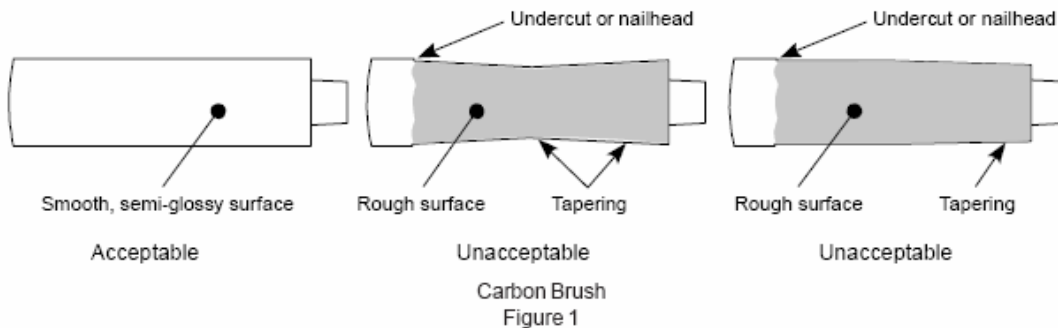
INSTRUCTIONS: 1. Use lighted magnification (4X minimum) to inspect carbon brush for rough surface and possible tapering. **REPLACE CARBON BRUSH THAT SHOWS ANY OF THE UNACCEPTABLE CONDITIONS SHOWN IN FIGURE 1 PER THE APPLICABLE MAINTENANCE AND OVERHAUL MANUAL.**

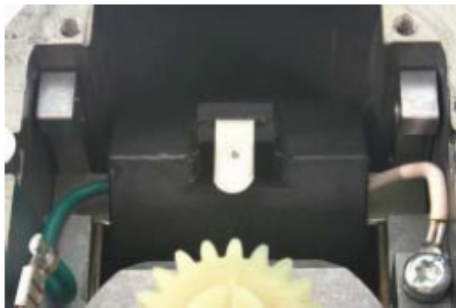
Acceptable

Evidence of Improper Wear of Carbon Brush
Figure 2

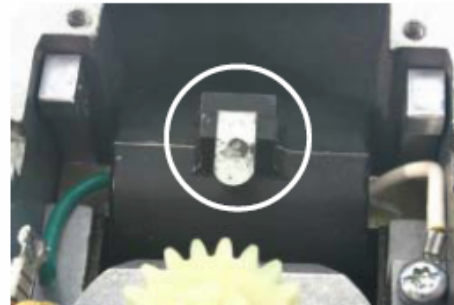
Unacceptable

- Inspect coil tab for carbon residue coating left by carbon brush. See Figure 2. **REPLACE CARBON BRUSH PER THE APPLICABLE MAINTENANCE AND OVERHAUL MANUAL IF SUBSTANTIAL RESIDUE IS FOUND ON COIL TAB.** Use a cotton swab and alcohol to remove residue from coil tab, or replace coil if tab cannot be cleaned. Also inspect high tension coil tab for wear caused by carbon brush. Wear is indicated by a visible depression in the tab. If tab is worn, replace coil.

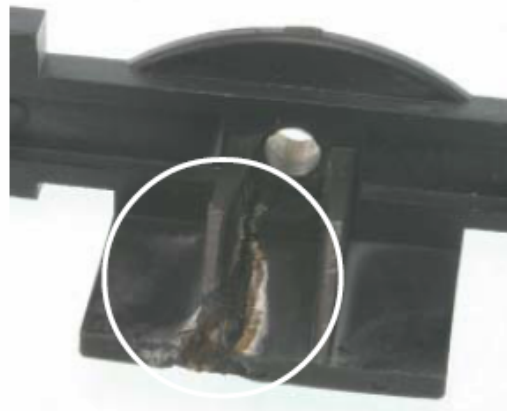
Bearing Bar
Figure 3

- Inspect bearing bar for evidence of brush residue contamination, burning, or arcing. See Figure 3. **REPLACE DISTRIBUTOR BLOCK ASSEMBLY PER THE APPLICABLE MAINTENANCE AND OVERHAUL MANUAL IF THERE IS ANY EVIDENCE OF ELECTRICAL ARCING OR BURNING.**

Unacceptable
(Developing bearing bar failure)

- If bearing bar does not show evidence of burning or arcing, clean and remove any normal residue per the applicable Maintenance and Overhaul Manual and reassemble into the magneto.

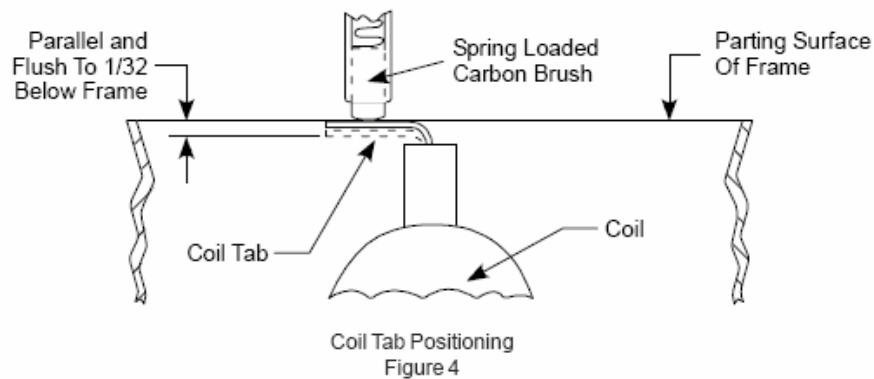
CAUTION: IF THE COIL TAB PROTRUDES ABOVE THE MAGNETO FRAME, IT CAN MAKE DIRECT CONTACT WITH THE DISTRIBUTOR GEAR AXLE AND CAUSE THE MAGNETO TO MALFUNCTION.

- Prior to installing distributor block, make sure coil tab is parallel to and flush with frame mating surface to within 1/32 inch. See Figure 4.
