Date: May 17, 2021

Subject: Superior Air Parts through-bolt part number SA641931-9.81 replacement

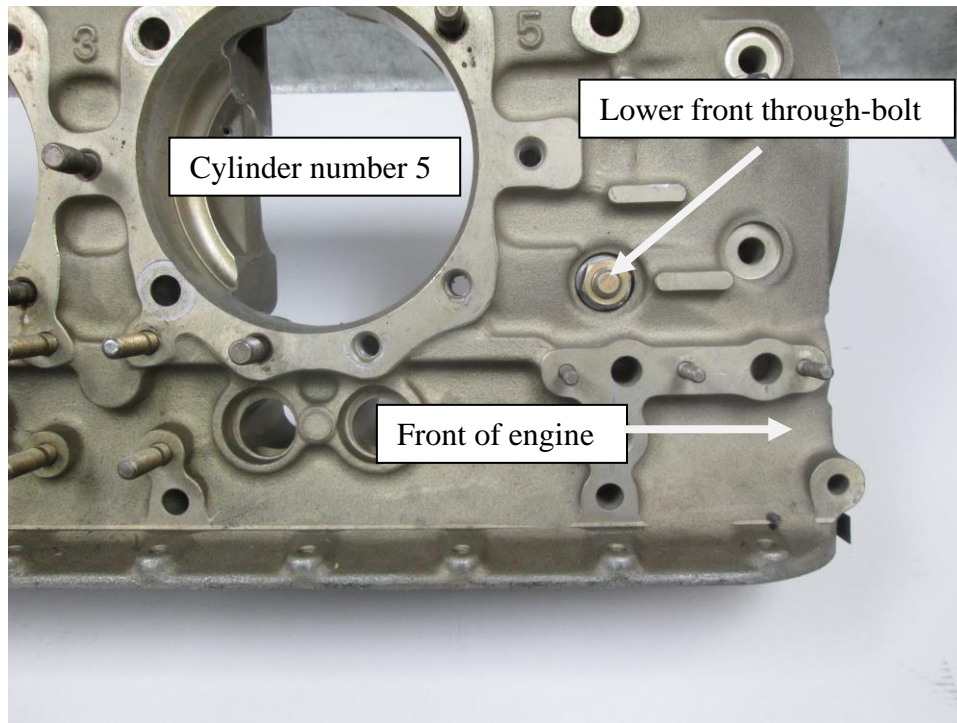
Illustration 1

Superior Air Parts has discovered that some of its part number SA641931-9.81 through-bolts were manufactured with the incorrect center O-ring groove section location as specified on the approved design. The incorrect placement of the grooves does not allow for the dowel feature in the bolt to engage properly on the right side of the crankcase which could lead to bearing distortion and crankcase fretting. Additionally, the sealing O-rings are required to be in the proper position to prevent oil seepage. Therefore, within the next 10 hours of service, perform the following:

- 2) Remove the lower front through-bolt in accordance with the Continental Motors Inc. maintenance or maintenance and overhaul manual. See illustration number 1 and 2
