# Service Bulletin

# B26-02

**Subject:** SL12892 Thrust Button Material Deformation at Rocker Shaft Location.

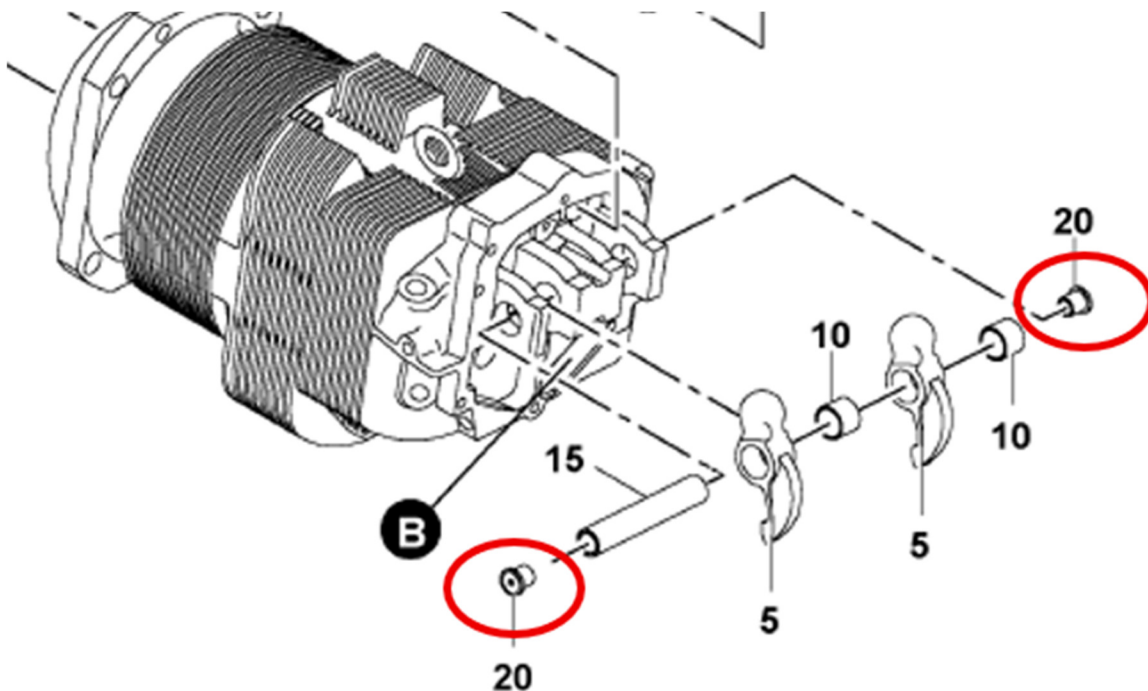
Field reports have identified thrust buttons manufactured from incorrect material that were installed at the rocker shaft location. When exposed to normal engine operating temperatures, the affected thrust buttons may deform, soften, or melt.

- A. Remove rocker covers, and gasket from the cylinder assembly, (discard rocker cover gasket).
- B. Inspect rocker box areas and rocker shafts for the following conditions:
  - Deformed/ Melted thrust buttons
  - Missing or partially missing thrust buttons
  - Inspect rocker cover area for material or residue
- C. Remove rocker shaft thrust buttons (20), part number SL12892, from each rocker shaft.
- D. Evaluate the condition of each removed thrust button and discard regardless of condition.

- A. Discard all removed thrust buttons regardless of condition.
- B. Install new thrust buttons using Service Kit **B26-02**.
- C. Install new rocker cover gaskets supplied in Service Kit **B26-02**.
- D. Reinstall rocker covers.
- E. Torque fasteners in accordance with the applicable engine maintenance manual.
- F. Make an engine logbook entry of compliance with Superior Air Parts Service Bulletin B26-02.
