>>> Service Letter

Number: L01-16A

Subject: Overhaul and repair procedures for Superior Propeller Governor Gearshaft.

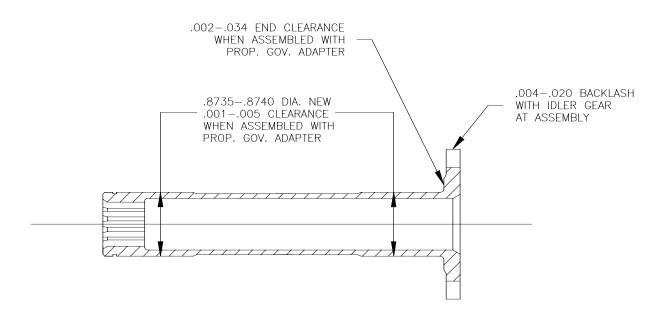
FIGURE 1 PROPELLER GOVERNOR GEARSHAFT

The gearshaft should be visually inspected for abnormal wear or damage, paying close attention to the gear teeth and internal spline. The gear assembly is to be magnetic particle inspected per ASTM E1444 and accepted per MIL-STD-1907, grade B (or other FAA approved repair station procedures). The allowable shaft size, clearances and gear backlash are shown in Figure 1.
