»» **Service Letter**

Number: L96-05A

Subject: Introduction of new single piece rocker arm bushing P/N SA520129 to replace the two P/N SA639629 or TCM639629 bushings.

Application: All inclined valve TCM470, 520 and 550 engines with two piece rocker arm bushings.

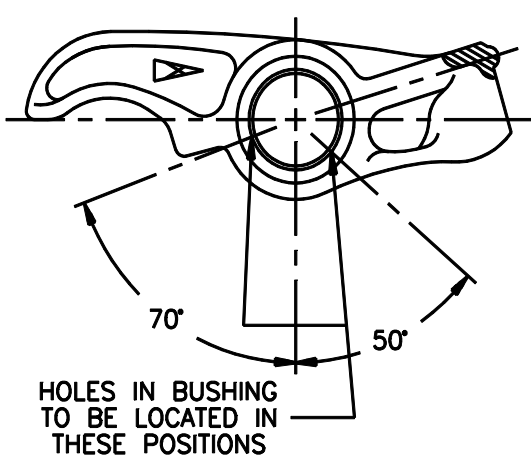
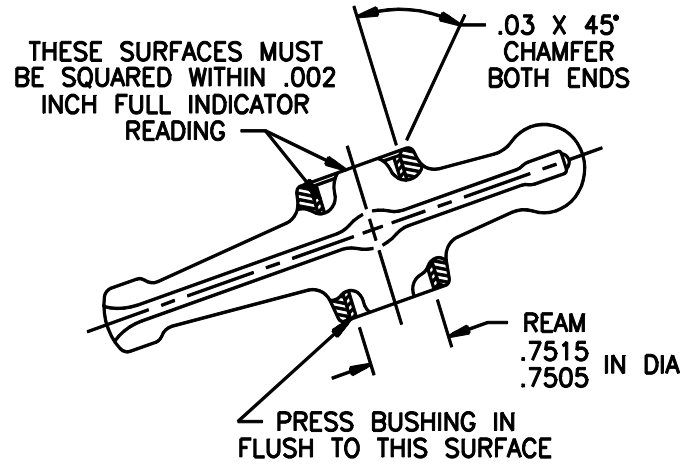
FIGURE 1

Superior now offers a one piece rocker arm bushing, P/N SA520129, as a replacement for the two bushings used in earlier Continental inclined valve 470, 520 and 550 engine cylinders. This bushing provides increased bushing area and reduces bushing and rocker shift wear.

The single piece bushing can only be installed in rocker arms originally equipped with the two piece bushing (Reference: P/N SA639629). These rocker arms do not have a groove machined in the rocker arm bushing bore.

Caution: No modification to the existing rocker arm is needed to install the new SA520129 bushing. The single piece P/N SA 520129 bushing is not to be installed in TCM rocker arm assembly P/Ns 652130, 652131 or later which have one piece TCM P/N 652129 bushings.

Replace the bushings as shown in Figure 1, with the holes positioned as shown. Prior to reaming, fill the holes in the bushing with beeswax to prevent chips from entering the oil passages. Ream as shown. After reaming, clean the oil passages with clean solvent. Assure that all passages are clear of obstructions and contamination.
