»» Service Letter

Number: L18-01 B
REPLACES L18-01A

Subject: Superior PMA Replacement Cylinder Assemblies With Corrosion Resistant Steel Exhaust Port Studs for Continental Motors, Inc. 520 and 550 Series Engines

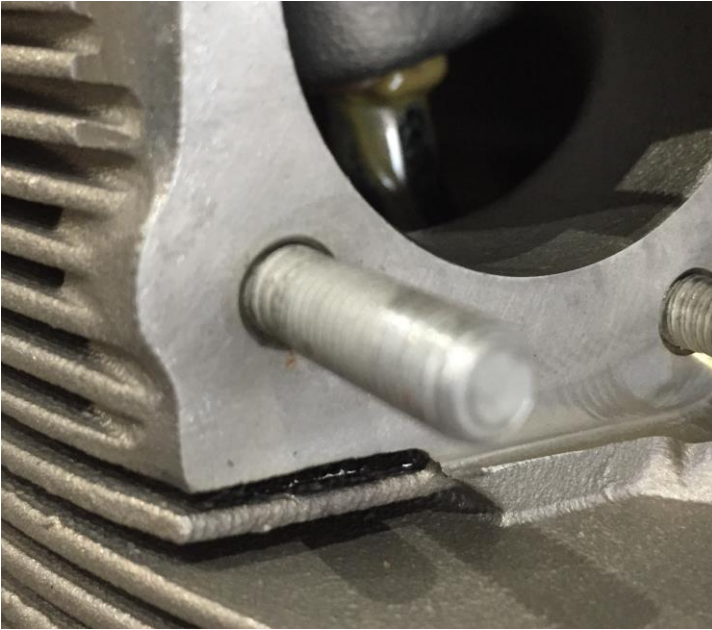
Figure 1 SA657985-1.38 CRS Stud

As noted above, the P/N SA657985-1.38 (and oversizes P003, P007, and P012) is an interference fit stud as opposed to the P/N SA638125 and P/N SA640482 ring lock type studs formerly used in the CMI 520 and 550 series Superior PMA replacement cylinder assemblies. The type of studs in your 520 or 550 cylinder(s) may be identified by referring to figures 1 and 2.

Cylinder Assemblies SA52006-A1 and SA55006-A1 with P/N SA657985-1.38 exhaust studs:

- 1) Using a suitable stud removing tool, remove the damaged studs.
- 2) Chase the threads with a ¼-20 UNC-3B tap.
- 3) Apply Lubriplate 105 or equivalent to the ¼-20 threads on the P/N SA657985-1.38 stud and, using an appropriate stud driving tool, drive the stud to a height of .875 ± .030 inch. The minimum allowable driving torque is 15 in-lbs. If this minimum torque is not achieved, repeat the installation using a P/N SA657985-1.38 P003 stud. The holes may also be tapped to ¼-20 P007 or ¼-20 P012 and the corresponding oversize stud installed.

A minimum driving torque of 15 in-lbs must be achieved.
