Service Letter

Number: L02-01 A

Subject: Fuel Injector Crack Inspection of older SA52000-A1 cylinder stud assemblies.

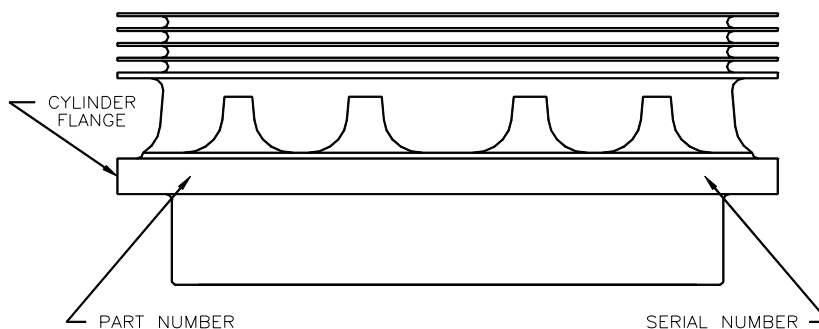
Figure 2

Cylinders that fall within Superior's warranty period may be submitted to a Superior Air Parts' Distributor for Warranty consideration. The cylinder's part number and serial number are identified on the cylinder flange, as shown in Figure 2. If a specific procedure is not addressed in this Service Letter, the applicable procedure in the original equipment manufacturer's current overhaul manual applies.
